Lubricant Cleanliness Matters

PERFORMANCE TESTING

Research **damage** progression of hydraulic system components to levels of **lubricant cleanliness**.

High Pressure Vane Pump Test Eaton 35VQ25

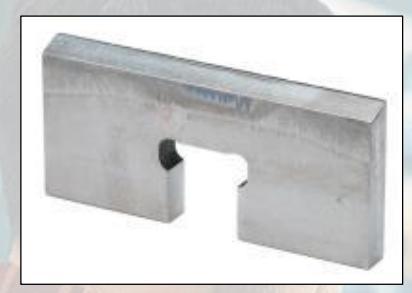
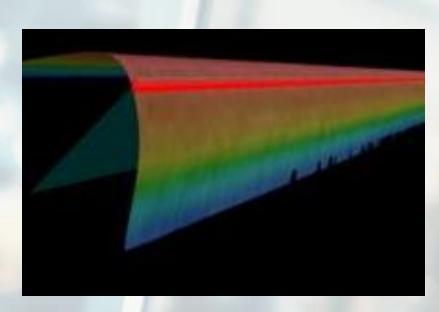
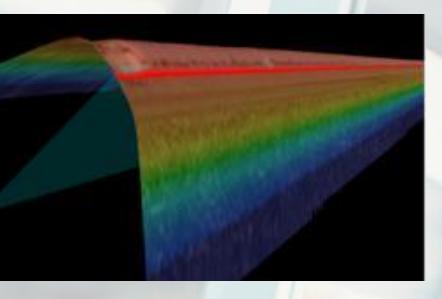
Vane Wear Progression End of Test

New Vane

Chevron Rando HD 32 – ISOCLEAN[®] Certified (150 hours) Typical Hydraulic Fluid B ISO 32 (128 hours)

Major impact on pump performance Leads to increased internal leakage causing cavitation. Diminishes proper flow & pressure efficiency.

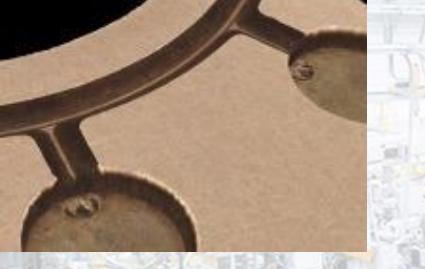
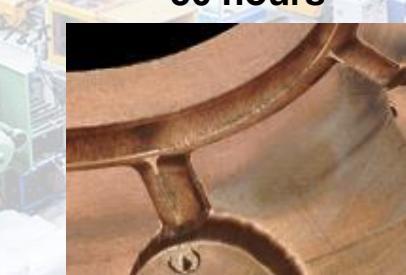
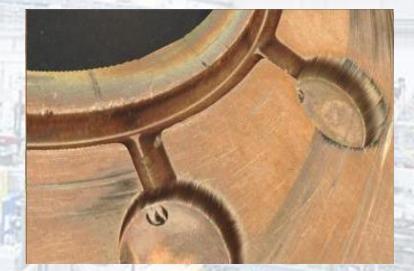
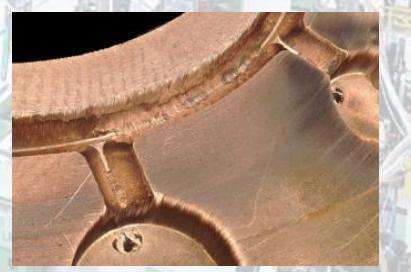
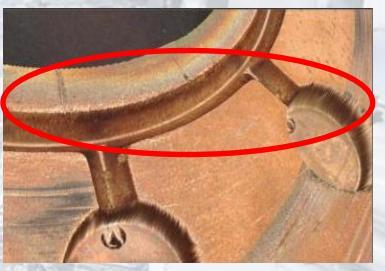
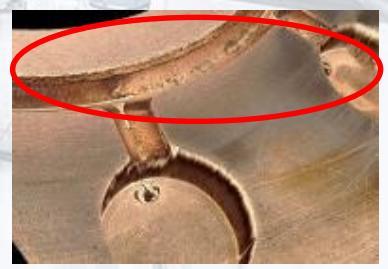
Side Plate Wear Progression

Chevron Rando[®] HD 32 – ISOCLEAN[®] Certified (System Filter)

New plate

50 hours

100 hours

150 hours

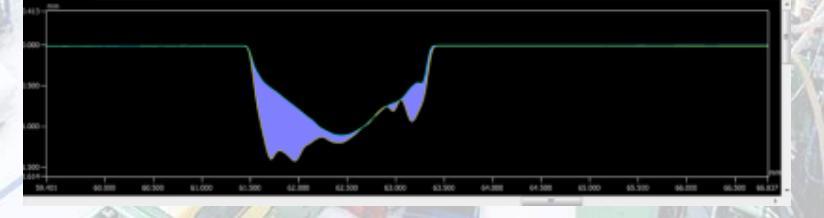
Side Plate V-Channel Wear Progression End of test (150 hours)

Chevron Rando® HD 32 ISOCLEAN® Certified (System Filter)

Typical Hydraulic Fluid B ISO 32 (System Filter)

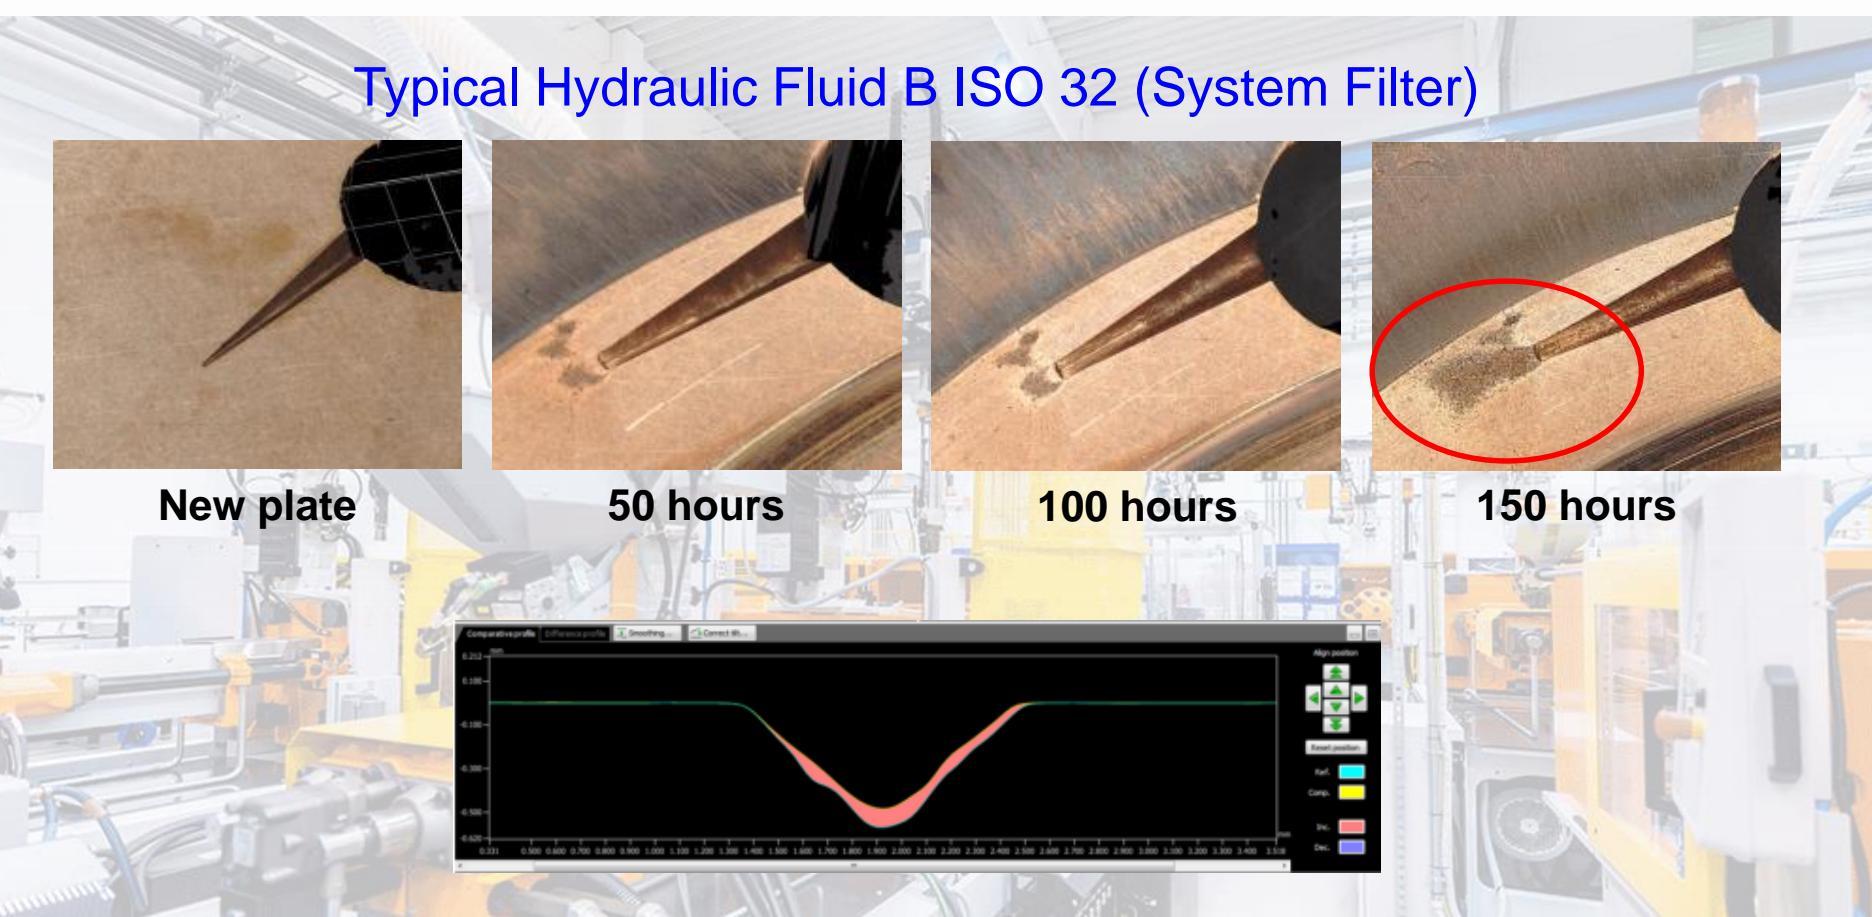
Side Plate Metering Edge Wear Progression

Slide Plate Metering Edge Wear Progression Typical Hydraulic Fluid B ISO 32 (System Filter)

Cavitation Erosion

Brass surface eroding due to particles and cavitation from Cam Ring.

Sandblasting & hammering (cavitation jet) action driving wear to support layer.

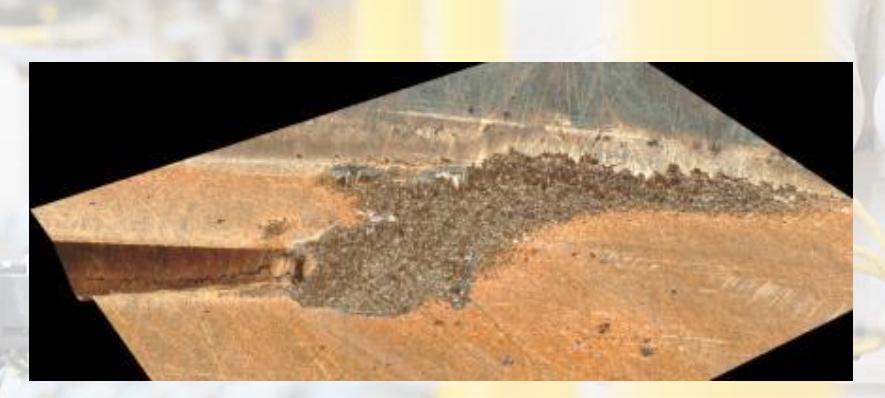
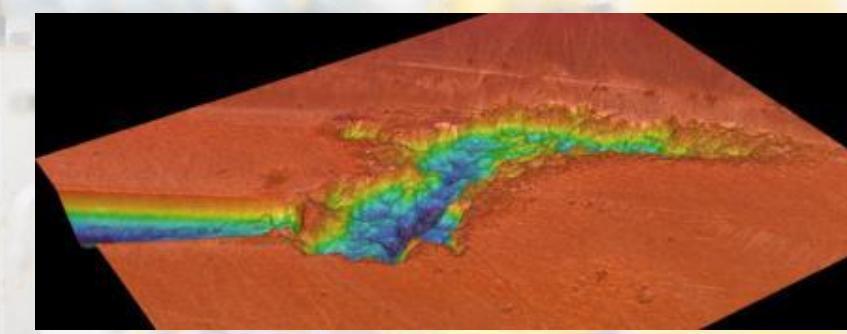
100 hours

Slide Plate Metering Edge Wear Progression Typical Hydraulic Fluid B ISO 32 (System Filter)

Particles deepening and widening channel.

Combination of particle erosion & cavitation causing damage

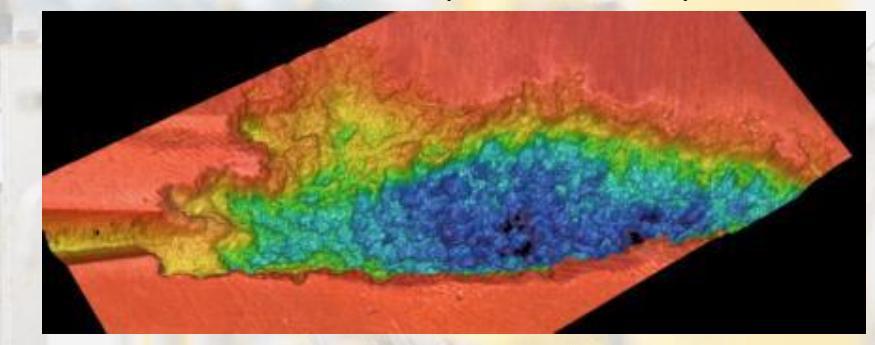
128 hours (End of test)

Damage has eroded through the top layer brass surface and almost completely through the below support surface.

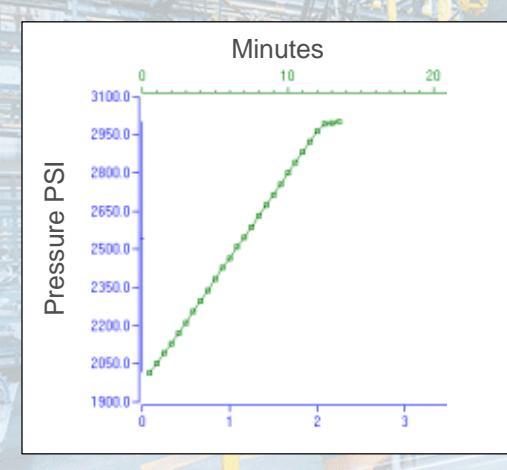
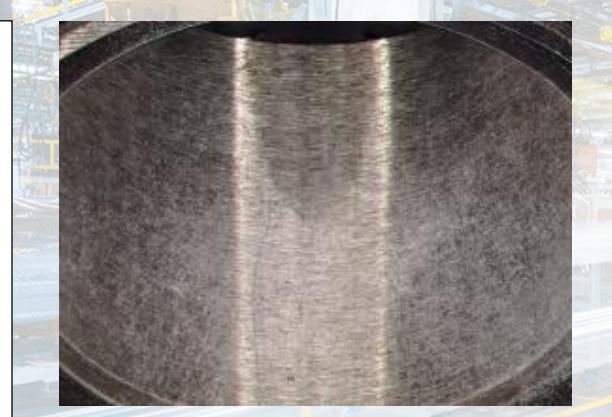
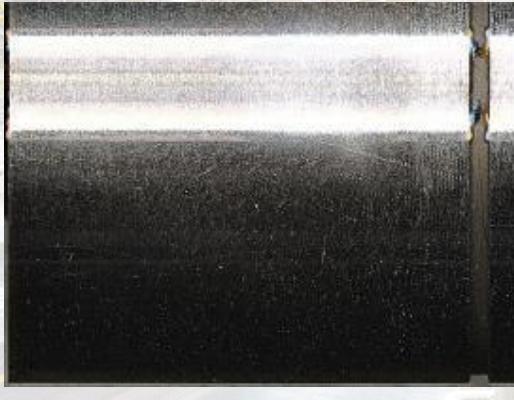
Pressure Control Valve

Chevron Rando[®] HD 32 – ISOCLEAN[®] Certified (System Filter)

Smooth pressure control curve **No interruptions** or signs of valve problems Valve cylinder shows **no wear rings** Valve piston **undamaged**

Valve Cylinder Bore

Valve Piston

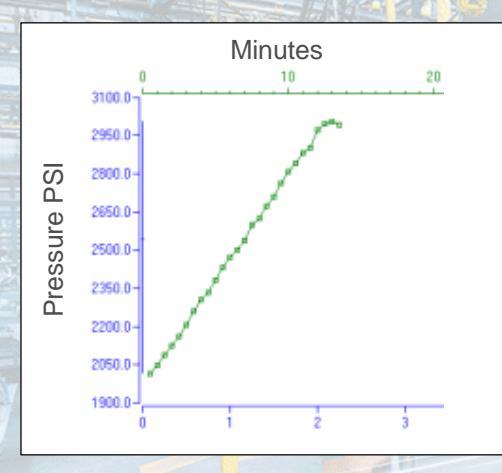
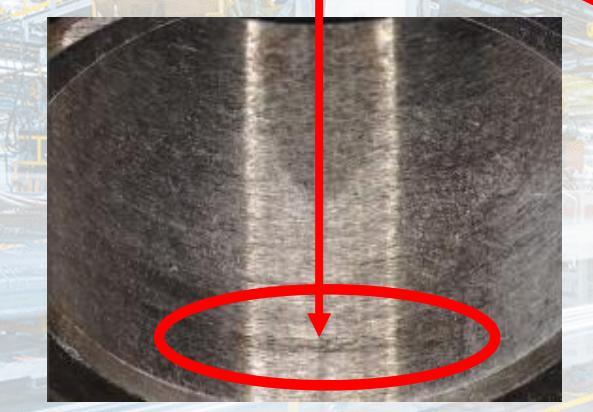
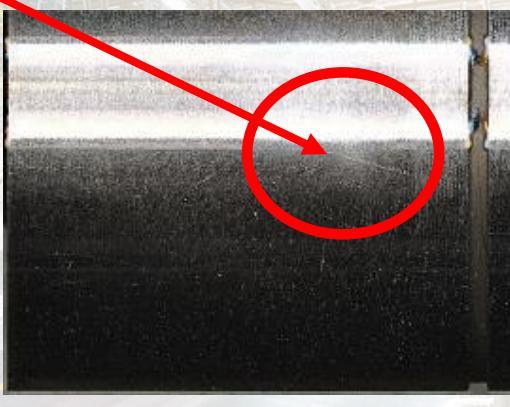
Pressure Control Valve

Typical Hydraulic Fluid B ISO 32 (System Filter)

Jumpy/jerky pressure control curve Signs of interruptions in valve caused by dirt or damage Valve cylinder shows signs of wear rings Valve piston shows slight sandblasting

Valve Cylinder Bore

Valve Piston

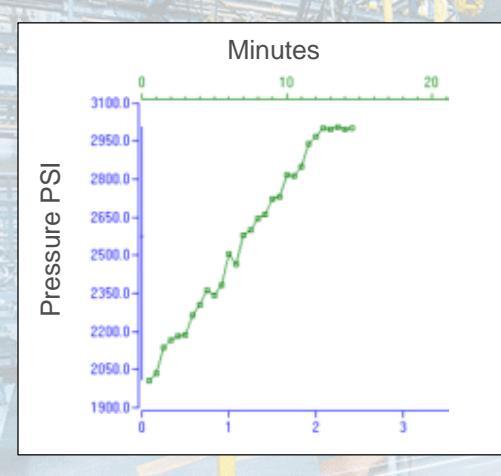
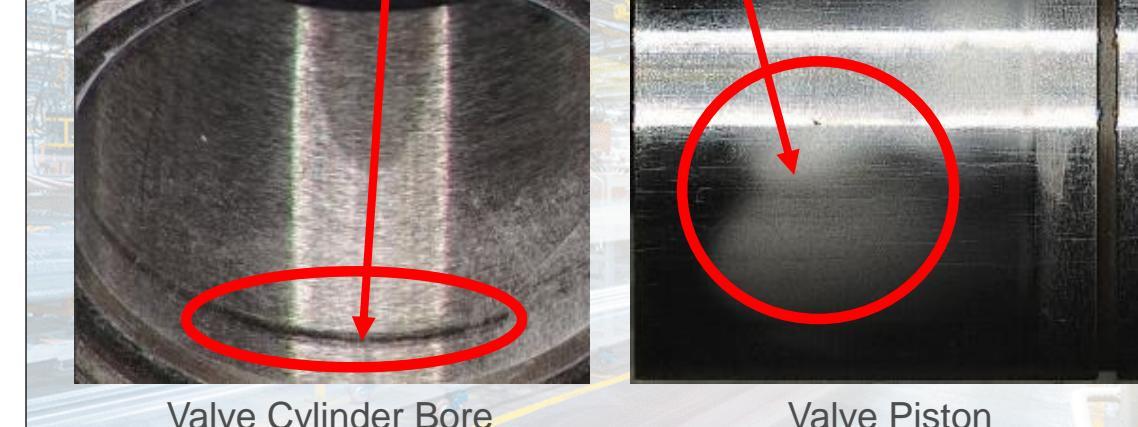
Pressure Control Valve

Typical Hydraulic Fluid C ISO 32 (Filter Bypass)

Extremely chaotic pressure control curve Signs of interruptions in valve caused by dirt or damage Valve cylinder shows clear wear ring Valve piston shows increased sandblasted area

Valve Cylinder Bore

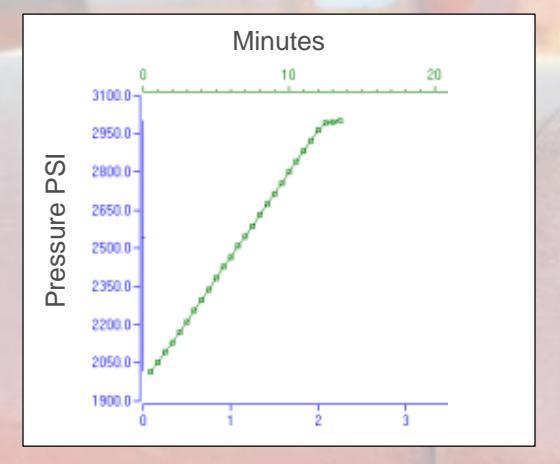
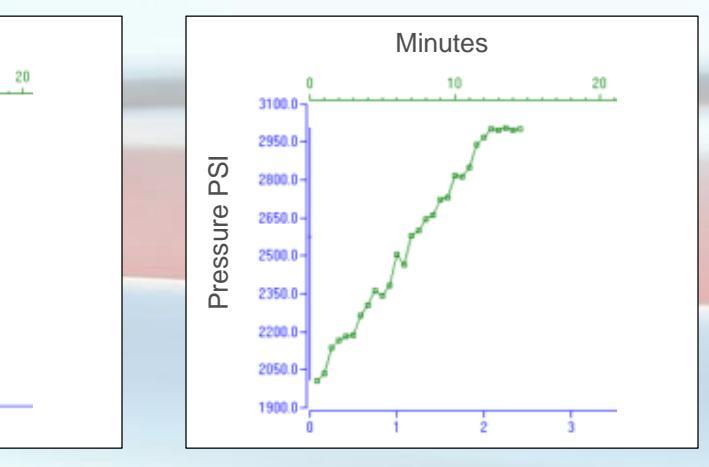
Hydraulic System Fluid Pressure

Chevron Rando[®] HD 32 ISOCLEAN[®] Certified

Typical Hydraulic Fluid B ISO 32

Typical Hydraulic Fluid C ISO 32 (Filter Bypass)

Pressure control valve loses ability to provide stable, smooth pressure.

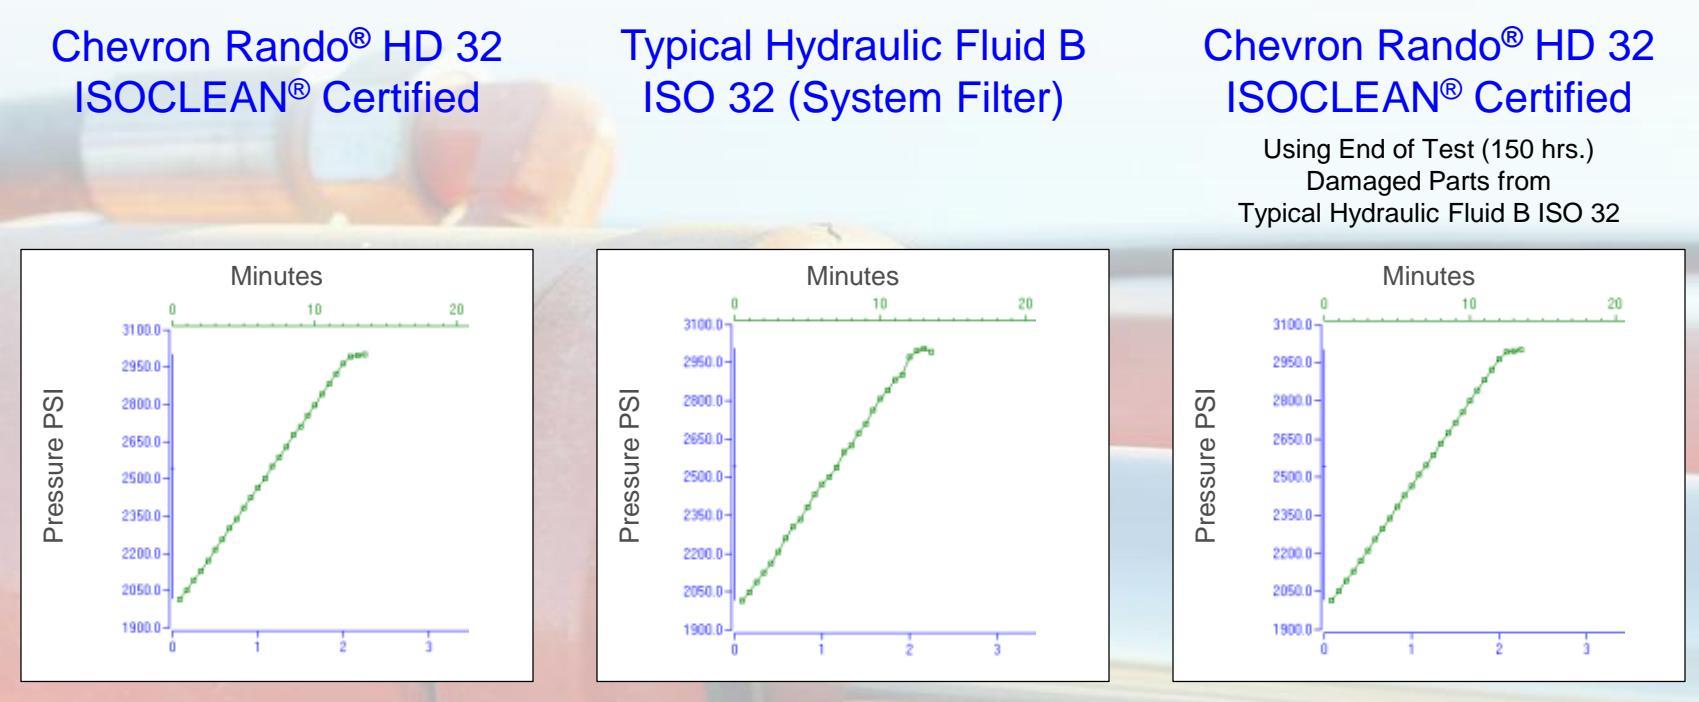
Fluid Pressure Test using End of Test Parts

Increasing cleanliness of hydraulic fluid can lead to increase in system efficiency.

System fluid pressure could stabilized when using Chevron ISOCLEAN[®] Certified Lubricant in previously damaged valve.
